INCIDENT ALERT

Normal
11/07/2007
00131

Neck strain sustained whilst descending from loading shovel

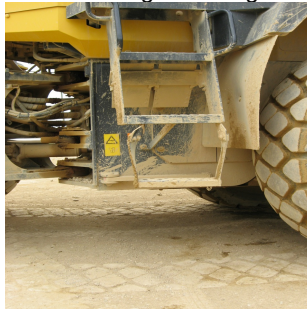
Whilst descending from a Komatsu W480 loading shovel, an operative 'jarred' his neck and shoulder as he strained to find his footing.

Steps leading down from loading shovel

The investigation found that although the driver descended in the correct manner, the flexible step moved and caused him to strain while attempting to find his footing. The step had also suffered some damage and the bracket was bent as a result. Additional findings show that mudguard sizes differ and in some cases are absent. This increases the likelihood of the step becoming muddy \ wet and further underlines the importance of daily \ operator plant checks.

A hydraulic step system has been ordered for the loading shovel. All personnel should be aware of this type of 'flexi' step and where possible, a new step system should be discussed and fitted, similar to the one shown below.

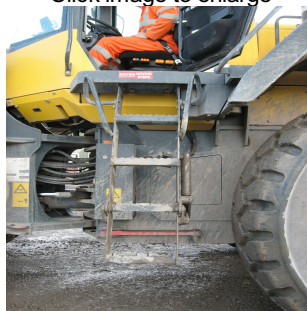
Hydraulic Flexi Step
