INCIDENT ALERT

LOCATION:	ON-HIGHWAY	ALERT STATUS:	Normal
ACTIVITY:	TRANSPORT / DELIVERY	DATE ISSUED:	24/06/2015 11:22:58
SUB ACTIVITY:	TIPPER	INCIDENT No:	01416

Tipper Body Floor (Steel Liners)

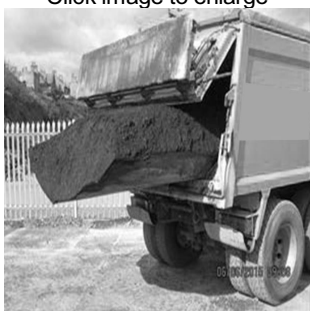
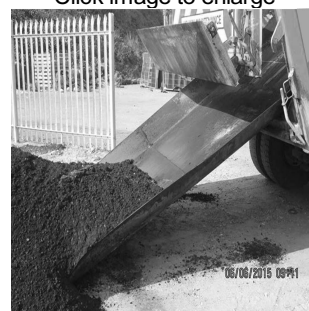
Recently on a contract surfacing site; a tipper truck was delivering asphalt to a machine lay operation. During the discharge of the load, the tipper body floor as a whole moved, as illustrated in the photographs.

After investigation it appears that the cause of the failure was that the fixings used to secure the liner to the body had corroded and failed as a result of galvanic corrosion, which is an electrochemical process. There has been a reaction between the alloy body and steel liner, which has caused the fixings to corrode and fail.

Since this incident, all the steel inserts have been thoroughly inspected and a replacement programme to fit an aluminium welded floor is underway. These trucks have been taken off asphalt deliveries until these steel inserts have been removed.

Truck drivers were instructed to inspect the tipper body floor as part of the daily checks for wear etc. and to report any defects immediately.
