Isolation lock out equipment near miss

LOCATION: AGGREGATE DREDGER
ACTIVITY: MAINTENANCE & HOUSEKEEPING
SUB ACTIVITY: N/A

ALERT STATUS: Normal
DATE ISSUED: 01/02/2016 12:49:05
INCIDENT No: 01425

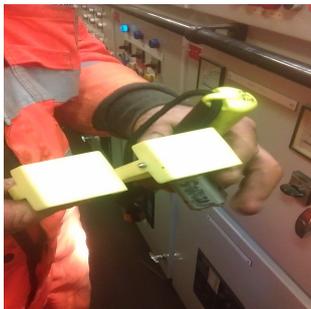
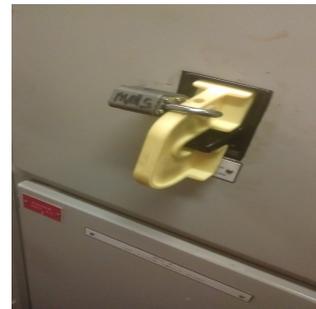
The equipment being isolated is switched on/off using a Bakelite switch, and the lockout equipment fits over the switch when it's in the off position. The equipment is fastened to the switch by a screw which grips switch and prevents the lockout from being removed. To prevent the screw being unscrewed a padlock is fitted which shields the screw head from a screw driver.

The lockout was fitted following procedure, however on inspection when the lockout equipment was touched and moved it slid off the

switch completely.

On investigation it transpires that because the switch is made of Bakelite which is hard and also brittle, it is not possible to screw the screw down on to the switch with sufficient purchase to gain enough grip to secure the lockout equipment in place.

A solution to this problem is currently under investigation.

Highlights the importance of testing and checking all aspects of the lock out process.
