INCIDENT ALERT

LOCATION: CONCRETE PRODUCTS PLANT
ACTIVITY: MAINTENANCE & HOUSEKEEPING
SUB ACTIVITY: N/A

ALERT STATUS: Normal
DATE ISSUED: 21/04/2016 13:23:27
INCIDENT No: 01428

Equipment mounted at height

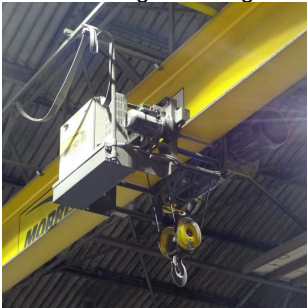
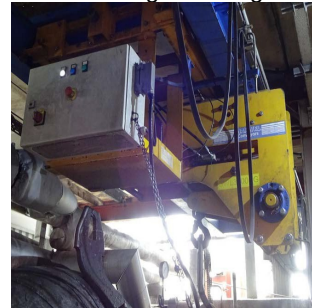
This alert is issued following a previous alert regarding the failure of a drive motor and gearbox mounted at height.

- Where individual component parts require replacing consider the benefit of replacing the whole assembly to avoid the potential for backlash.
- Carry out assessments identifying areas where equipment is mounted / travels over people, consider fitting a secondary securing device.

- Secondary securing devices prevent a component falling from height if the primary securing method fails. This could be a safety wire or some other engineered method designed for this function. Secondary securing devices should be sufficient to withstand the shock loading that may occur if the primary securing method fails.
