INCIDENT ALERT

LOCATION:	COMPANY-WIDE	ALERT STATUS:	Normal
ACTIVITY:	MAINTENANCE & HOUSEKEEPING	DATE ISSUED:	31/05/2016 12:13:15
SUB ACTIVITY:	N/A	INCIDENT No:	01432

Tyre fitter trapped under foam filled tyre

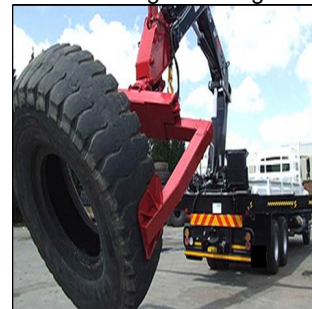
A contract tyre fitter (IP) working on a hired loading shovel suffered bruising to his right arm and left leg after becoming trapped beneath a foam filled tyre and wheel assembly, when the tyre fell onto him after he unbolted the wheel in preparation for changing the tyre - see Photograph 1.

- The loading shovel was on hire and neither the Company nor the tyre fitter knew the tyre was foam filled.
- The IP assumed it was a punctured air-filled tyre because it had deflated (the foam inside the tyre had deteriorated giving the appearance of a punctured pneumatic tyre – foam tyres don't normally deflate).
- The foam filled tyre weighed in excess of 400kg (two or three times heavier than an air filled tyre). It took two people to lift the tyre off the trapped fitter.

- Only Company approved tyre fitters shall be used to change and repair tyres on mobile plant - this is regardless of ownership of the machine i.e. on owned/hired/leased.
- Tyres and wheels on mobile plant must only be removed using proprietary mechanical tyre-handling equipment like the one shown in Photograph 2
- Before undertaking any work on mobile plant tyres the type of tyre filling must be established and a thorough risk assessment must be undertaken to ensure the work is planned and carried out safely.
