# Incident involving the transport of dump trucks 50 tonnes and over

| LOCATION: | MOBILE PLANT | ALERT STATUS: | Normal |
| ACTIMTY: | TRANSPORT & LOGISTICS / DELIVERY | DATE ISSUED: | 05/12/2016 16:05:27 |
| SUB ACTIVITY: | LOADING | INCIDENT No: | 01444 |

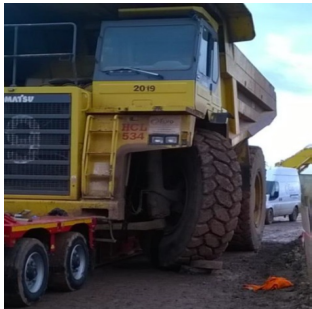
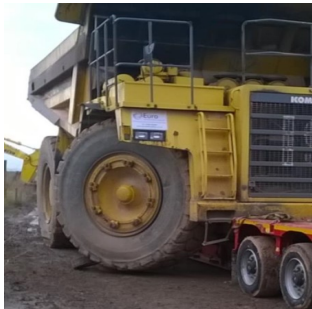
On assessing the site, it appears that the wheels had turned from parallel to the vehicle sides to their final resting position, by the offside rolling forward off the block on which it was elevated; and the near side rolling backwards.

What is not clear, is what caused this movement, from what had been a stable position for some time; to slow initial movement and then quicker in its final moments. The fact that the nearside tyre was not inflated to the same level as the off side one and the vehicle had not run for some time may have been contributing factors.

- The fact that the wheel moved while on the single sleeper, suggests this is not the ultimate solution as without the excavator bucket in place, the forces involved could move the sleeper
- What was required is something that physically stopped the wheels from pivoting.

Although not conclusive, it was felt that the extra length of the railway sleeper would offer some additional protection and this method was used, with the excavator bucket braced against the wheel to prevent any pivot movement, when carrying out the final tightening process to this DT.

This DT was collected on a beam trailer, without the mattress boards on either side being installed, which gave the space for the wheel to pivot.

By installing these mattress boards, the width across the trailer is increased, limiting the space for movement of the wheel if this were to pivot. The use of low loader trailers would have a similar limiting effect, protecting anyone working in the wheel arches from being trapped.
