# Smouldering Fire Cloth

**LOCATION:** AGGREGATE DREDGER  
**ACTIVITY:** MAINTENANCE & HOUSEKEEPING  
**SUB ACTIVITY:** N/A

**ALERT STATUS:** Normal  
**DATE ISSUED:** 10/07/2017 10:44:43  
**INCIDENT No:** 01461

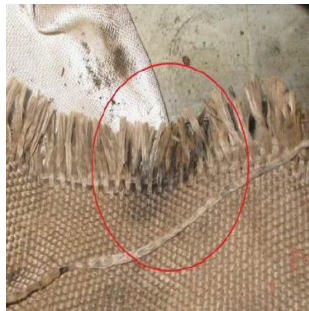
A risk assessment had been completed, control measures implemented and the permit to work issued. Just after welding began, smoke started to emit from the fire cloth next to where welding was taking place. As the cause of this was not clear, and as a precaution to prevent any fire spreading, a closely sited fire extinguisher was used on the area that was smoking. The fire cloth was then taken out into the open air.

The Ship's Safety Officer's investigation identified that prior to use, the fire cloth had become contaminated with grease / oily residue and the sparks from the welding operation had caused the fire cloth to begin to smoulder.

- Competent Persons to ensure that all equipment is thoroughly inspected prior to the start of hot work or any work where there is risk of fire.
- Shipboard Safety Officers to verify at their statutory safety officer inspections, that fire prevention and fire fighting equipment is not exposed to contamination or deterioration.
- Fire cloths or other fire prevention equipment must be clearly quarantined or marked accordingly if found to be contaminated so that it is not inadvertently used prior to discarding ashore.
