## INCIDENT ALERT

<b>LOCATION:</b>	<b>ON-HIGHWAY</b>	<b>ALERT STATUS:</b>	<b>Normal</b>
<b>ACTIVITY:</b>	<b>TRANSPORT / DELIVERY</b>	<b>DATE ISSUED:</b>	<b>08/08/2017 10:43:48</b>
<b>SUB ACTIVITY:</b>	<b>ON-HIGHWAY</b>	<b>INCIDENT No:</b>	<b>01463</b>

**60t Crane Rollover**

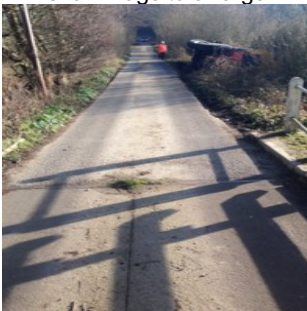
The road is very narrow with foliage on one side, and a soft verge and 5 foot deep ditch on the other. A rut had developed at the roadside and it appears that the front wheel of the crane dropped into this.

**Access Road**

- Effective journey planning would have identified a different route to site
- Keep away from unmarked edges and soft roadside verges

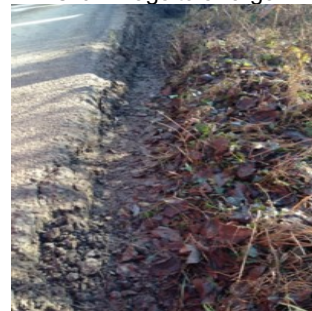
The driver continued onwards and tried to steer the crane out of the rut, but was unsuccessful; the trailing wheels also dropped into the rut and eventually the soft verge gave way, causing the crane to overturn.

**Rut to side of road**

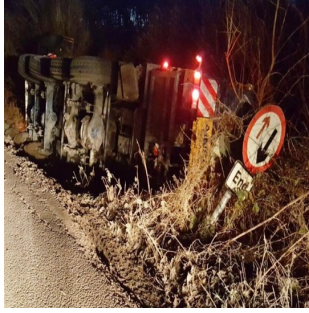
**Overtuned Crane**

- Remind drivers about the dangers of soft verges, and how easily a vehicle can roll over.
- Wearing a seat belt and not carrying any loose equipment in the cab will help to prevent injuries
- Journey Planning should be undertaken for all deliveries, and could identify where an alternative / safer route is necessary. In this case a movement order had been applied for but had not been issued. The Police had instructed the crane provider to use an alternative route but this had not been communicated to the driver.
