Danger of using the wrong disc on angle grinders

LOCATION: AGGREGATE DREDGER
ACTIVITY: MAINTENANCE & HOUSEKEEPING
SUB ACTIVITY: N/A

ALERT STATUS: Normal
DATE ISSUED: 11/10/2017 11:27:09
INCIDENT No: 01472

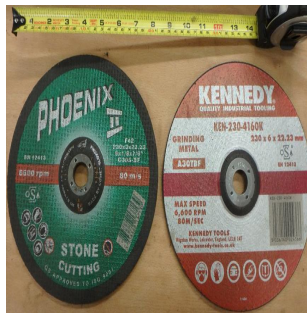
The Chief Engineer on board a marine aggregate dredger was in the process of carrying out a stock take of cutting and grinding equipment. During this check, two cutting discs were found that were designed for cutting stone, a task which is unlikely to be necessary on board. It was assumed that the discs had been purchased and/or received in error.

Due to strong centrifugal forces, it is probable that if stone cutting discs are incorrectly used for cutting steel, they would overheat and shatter, or due to the unintended cutting material, a kick-back would occur, where the angle grinder is violently thrust back. Both results have the potential to result in serious personal injury.

Image shows difference in discs

- On every occasion when using an angle grinder, ensure the cutting disc is appropriate to the material intended to service. Be aware that there are four main types of cutting disc design: steel, stainless steel, aluminium and stone.

- Ensure all cutting discs on board are manufactured to standard: EN 12413. This is a strict safety standard with specified requirements for bonded abrasive products. All discs should be clearly marked to reflect this.

- Cutting discs should be inspected prior to use to ensure they are within their age expired date (typically three years from date of manufacture). This should be clearly marked on the metal centre ring.

- If carrying cutting discs of varying intended designs, segregate these as much as possible.
- When working with cutting discs particular attention must be taken when handling them as the severity of a chip or crack can intensify rapidly when spinning at 80m/s.
