INCIDENT ALERT

LOCATION:	LIME & SLAG PLANTS	ALERT STATUS:	Normal
ACTIVITY:	TRANSPORT / DELIVERY	DATE ISSUED:	12/10/2017 12:21:43
SUB ACTIVITY:	LOADING	INCIDENT No:	01473

Bulk Tipper Trailer Ram Failure

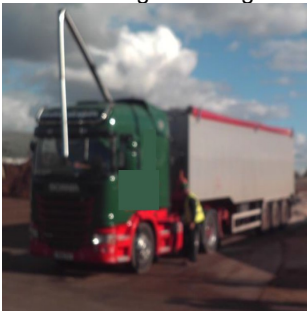
Whilst a load was being discharged from a bulk tipper onto a storage pad, the top ram mounting bolts failed. This resulted in the unsupported trailer body falling approximately 15 metres onto the chassis and the tipping ram striking the top of tractor unit cab.

Final Ram Position

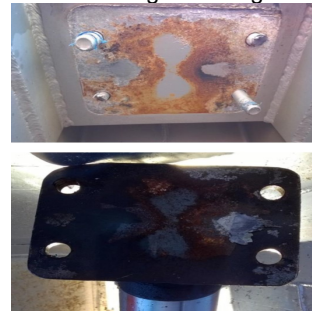
- Tipper ram was fully extended
- Load was not free-flowing
- Driver moved trailer < 2metres to discharge load
- Tipper ram was not connected to trailer
- 4 mechanical fasteners had failed (2 had sheared off and there was evidence of metal fatigue, 2 had stripped off nyloc nuts from threads)
- Trailer was first registered 07.11.13

Trailer Tipper Ram Mountings

Ensure that any inspection and maintenance regime, takes into account other critical components that are not part of a mandatory VOSA inspection regime; in this case, the ram top mounting fasteners.

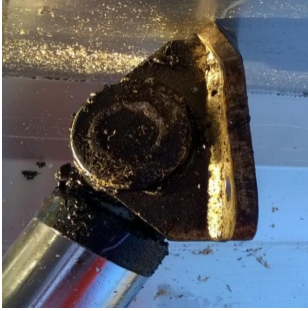
- Two of the mechanical fasteners showed evidence of metal fatigue
- The inspection and maintenance regime had been ineffective
- Fixings are not part of the mandatory Vehicle Operator Services Agency (VOSA) inspection regime

Trailer Tipper Ram Mountings

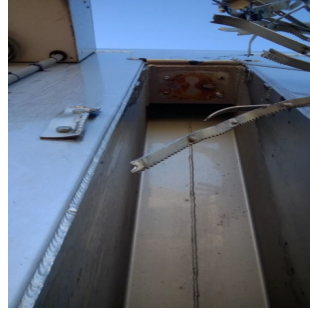
Top of Tipper Ram Mounting Plate
