Mechanical handling injury on dredger due to maintenance regime

LOCATION: AGGREGATE DREDGER
ACTIVITY: MAINTENANCE & HOUSEKEEPING
SUB ACTIVITY: N/A

ALERT STATUS: Normal
DATE ISSUED: 16/10/2017 11:17:36
INCIDENT No: 01474

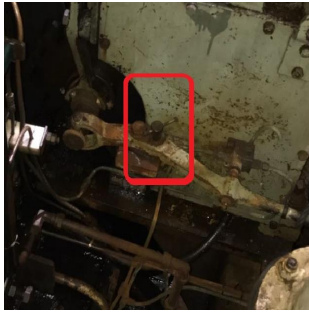
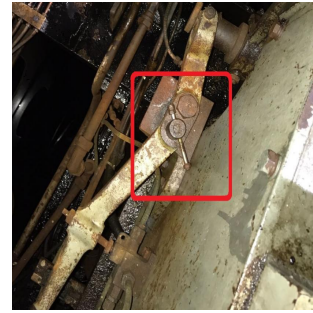
The pin for the turning gear had seized due to a sea water leak from the air cooler drain dripping on the pin causing it to become corroded.

When the Duty Engineer tried to release the pin (unaware that it was seized), he strained his left shoulder. The injury required medical assessment, which diagnosed rest and the use of painkillers.

Inadequate inspection and maintenance regime in place to ensure the satisfactory working of the specified shipboard equipment.

Planned Maintenance Job Card added for the Turning Gear Pin, requiring inspection on a frequent basis and periodic lubrication.

Risk assessment and Safe Working Practice for the operation reviewed to ensure that the hazard of “engaging and disengaging the turning gear pin” is considered.
