INCIDENT ALERT

LOCATION: AGGREGATE DREDGER
ACTIVITY: MAINTENANCE & HOUSEKEEPING
SUB ACTIVITY: N/A

ALERT STATUS: Normal
DATE ISSUED: 16/10/2017 11:17:36
INCIDENT No: 01474

Mechanical handling injury on dredger due to maintenance regime

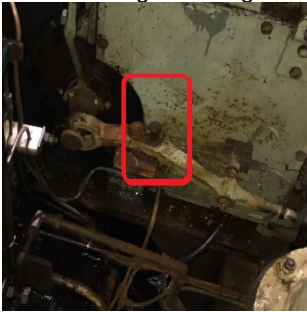
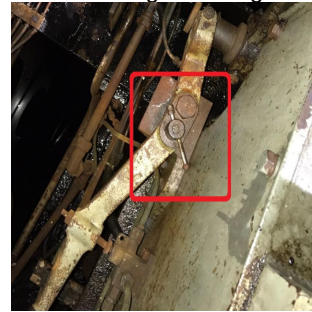
The pin for the turning gear had seized due to a sea water leak from the air cooler drain dripping on the pin causing it to become corroded.

When the Duty Engineer tried to release the pin (unaware that it was seized), he strained his left shoulder. The injury required medical assessment, which diagnosed rest and the use of painkillers.

Inadequate inspection and maintenance regime in place to ensure the satisfactory working of the specified shipboard equipment.

Planned Maintenance Job Card added for the Turning Gear Pin, requiring inspection on a frequent basis and periodic lubrication.

Risk assessment and Safe Working Practice for the operation reviewed to ensure that the hazard of "engaging and disengaging the turning gear pin" is considered.
