INCIDENT ALERT

LOCATION:	ASPHALT/COATING PLANT	ALERT STATUS:	Normal
ACTIVITY:	TRANSPORT / DELIVERY	DATE ISSUED:	07/11/2017 11:49:13
SUB ACTIVITY:	LOADING	INCIDENT No:	01477

FEL Contact with Customer Vehicle

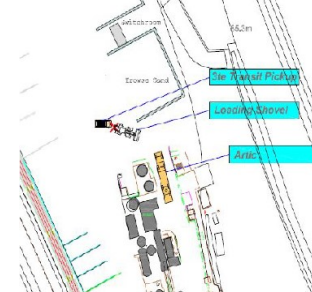
Position of Vehicles

The driver went to drive around to the front of the plant when he noticed an arctic coming towards him. He reversed to allow the arctic to pass, not noticing the collect customer in a transit van who had driven up behind the FEL. The counter weight of the FEL came into contact with the customer vehicle causing minor damage to the vehicle.

- Ensure hauliers who are new to site have an induction / orientation to warn of site hazards and that this is recorded.
- Review Vehicle/Pedestrian Management Plan to ensure that, wherever possible, site vehicles are separated from road vehicles on site.
- In restricted plants consider adopting a '5+2' rule where a 5m exclusion zone is enforced in front and behind a vehicle and 2m either side.
- Share this brief with staff showing the dangers of not checking behind adequately when reversing.
- Verify that VMS / Radar systems on mobile plant have been subject to risk assessment and have been calibrated to the working area and is effective.
- Review daily mobile plant inspections to ensure that all defects are being reported as required.
