Front End Loader in water pit incident

ALERT STATUS: High Potential
DATE ISSUED: 04/06/2018 15:29:23
INCIDENT No: 01491

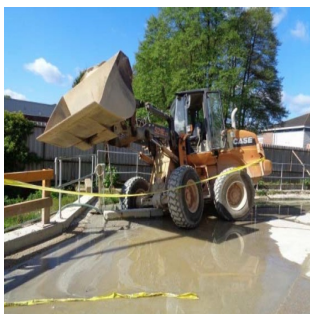
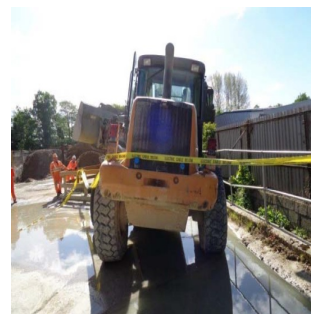
A front end loading shovel (FEL), entered a small water pit when the operator drove over a storm drain cover. This pit was situated along one edge of the yard and was adjoining a storm drain that connects to a nearby stream. The weight of the FEL caused the drain cover to collapse which in-turn caused the FEL to lean at a dangerous angle, presenting the potential of it tipping over.

- Limited all-round visibility – operator failed to see the drain cover under surface water
- Lack of adequate edge protection around water pit
- FEL fitted with standard vision mirrors only - wide angle convex mirrors should have been installed as well
- Contracted operator did not possess MPQC card or evidence of competencies concerning the operation of a FEL.

Following the incident on site, the FEL was turned off and the operator evacuated. The area was cordoned off to stop any entry and the machine was removed by a hired in heavy recovery truck. The driver was debriefed about the incident and completed a drugs and alcohol check.

- Edge protection around water pit to be improved FEL to be fitted with wide angle convex mirrors as well as standard vision mirrors
- An All Round Vision Assessment will be completed.
- Remind operators to never enter flooded areas unless they know what is beneath the surface
- Checks to ensure that all operators have undergone the required training and possess recognised competencies such as MPQC.
