Fatal 6 - Seaman struck by mooring line

LOCATION:	AGGREGATE DREDGER	ALERT STATUS:	Normal
ACTIVITY:	MARINE OPERATIONS	DATE ISSUED:	01/10/2019 11:34:09
SUB ACTIVITY:	SHIP TO SHORE	INCIDENT No:	01528

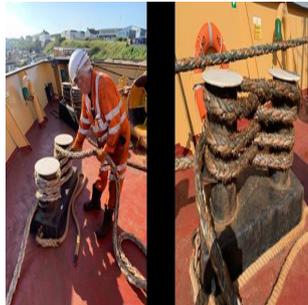
The vessel continued to move ahead slightly; placing strain on the secured mooring line. The mooring line surged (slipped) on the mooring bitts; the standing (unloaded) part of the line whipped from the deck, striking the Seaman in the groin.

- The mooring equipment in the vessel is undersized by contemporary standards for the rope size in use.
- Mooring equipment standards have been formalised/ amended several time since the vessel was constructed.

- The layout of mooring equipment in the vessel precluded use of best operational practice for use in service.
- Standard induction procedures were followed; however, could have been improved with more focus on ship specific issues.

- Co-ordination of communications and actions of the Bridge Team and instructions given to Deck Crew could be improved.
- Minor proportionate modification to Deck mooring equipment would be beneficial to eliminate an identified deficiency.

- There was no specific mooring plan in place for the task.

- A study to evaluate modification of the mooring bitts involved in this incident should be undertaken to determine whether a deficiency in layout can be eliminated.
