## INCIDENT ALERT

**LOCATION:** AGGREGATE DREDGER  
**ACTIVITY:** ACCESS & EGRESS & WORKING AT HEIGHT  
**SUB ACTIVITY:** N/A

**ALERT STATUS:** High Potential  
**DATE ISSUED:** 13/01/2020 11:50:26  
**INCIDENT No:** 01543

Fatal 6 - Working at height - high potential near hit

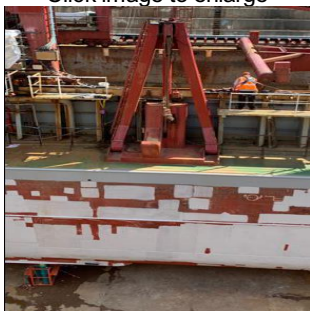
Image 'a'

The Contractor was only wearing a single tail work restraint lanyard (the RA had identified that two lanyards were required for the task). During the work activity the contractor was observed moving off the safety walkway onto the intermediate gantry without using the specified twin lanyards and without clipping his single lanyard to a securing point, thus exposing himself to a potential 10 metre fall (image 'a'). Once reaching the intermediate gantry, the single lanyard was then incorrectly attached to a vertical wire and not to a fixed point. In the event of a potential fall from this point, the lanyard would have slid down the length of the wire rather than arresting the fall (image 'b').

- Vessels should discuss this Safety Alert note at their next Safety Briefing held on-board and ask the question could this incident happen on my watch?
- Vessels should review all activities involving Working at Height and ensure the risk assessments are suitable and sufficient for the activity.
- Masters should include this Safety Alert in their Handover notes to ensure this information is passed onto their opposite watch.
