INCIDENT ALERT

LOCATION: AGGREGATE DREDGER
ACTIVITY: ACCESS & EGRESS & WORKING AT HEIGHT
SUB ACTIVITY: N/A

TITLE

Fatal 6 - Working at height - BMAPA Alert

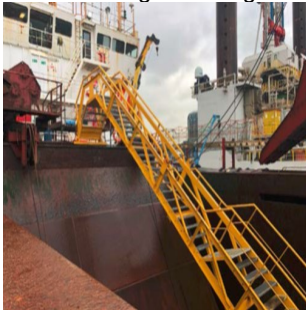
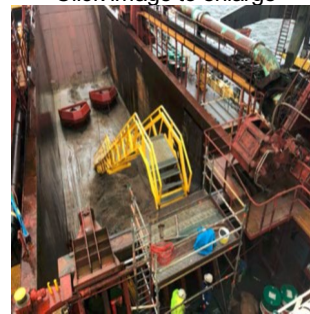
The Permit to Work did not cover the removing of the scaffolding, employees were not certified scaffolders and they were not wearing safety harnesses. As a result of the handrails being removed, they had exposed themselves to a 10m fall into the bottom of the cargo hold. The vessels Safety Officer intervened, stopped the job and removed the employees from the vessel.

Shows where scaffolding was removed

- Lack of risk awareness by repair yard employees with regard to Working at Height and of following clear safety procedures.
- The employees were not trained, authorised or competent to dismantle scaffolding
- The initial investigation report from the repair yard was unsatisfactory.
