# INCIDENT ALERT

**ALERT STATUS:** High Potential  
**DATE ISSUED:** 03/04/2020 16:35:57  
**INCIDENT No:** 02554

'The Fatal 6' - Unsafe Work at Height & Isolation Breach

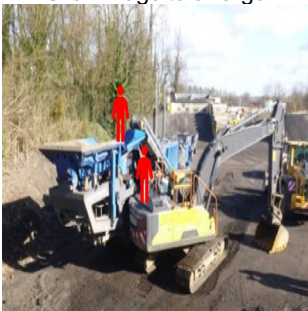
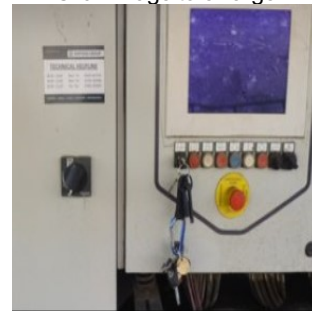
Contractors were observed working unsafely on a mobile crusher - the crusher wasn't fully isolated as per Company procedures and their transport vehicle was left unattended with the engine running.

- Contractors had been inducted, and clearance to work issued for the RAP crushing operation
- The clearance to work did not include any maintenance that might be required for the equipment
- Unauthorised maintenance was being carried out by the contractor
- Isolation information was part of the induction regarding Company processes
- Equipment was not fully isolated by the contractor and the contractor did not contact any Company employee regarding the need for isolation
- Work at height was not controlled adequately or an authorised activity by the contractor

- All contractors must have a specified Company person who will be their point of contact
- The Company person must carry out and document regular interactions with the contractors whilst on site to ensure task-specific controls are in place and being followed
- All equipment before being worked on must have a Company isolation owner
- All working at height must be adequately controlled through robust HIRA (Hazard Identification & Risk Assessment) and Methods of Work
- All work carried out by contractors must be authorised by Company management.
