'The Fatal 6' - Unsafe Work at Height & Isolation Breach

ALERT STATUS: High Potential
DATE ISSUED: 03/04/2020 16:35:57
INCIDENT No: 02554

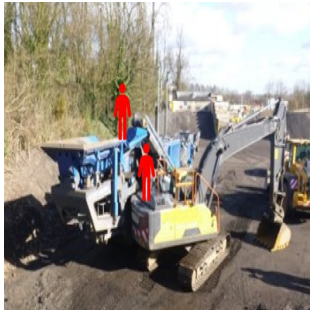
Contractors were observed working unsafely on a mobile crusher - the crusher wasn't fully isolated as per Company procedures and their transport vehicle was left unattended with the engine running.

- Contractors had been inducted, and clearance to work issued for the RAP crushing operation
- The clearance to work did not include any maintenance that might be required for the equipment
- Unauthorised maintenance was being carried out by the contractor
- Isolation information was part of the induction regarding Company processes
- Equipment was not fully isolated by the contractor and the contractor did not contact any Company employee regarding the need for isolation
- Work at height was not controlled adequately or an authorised activity by the contractor

- All contractors must have a specified Company person who will be their point of contact
- The Company person must carry out and document regular interactions with the contractors whilst on site to ensure task-specific controls are in place and being followed
- All equipment before being worked on must have a Company isolation owner
- All working at height must be adequately controlled through robust HIRA (Hazard Identification & Risk Assessment) and Methods of Work
- All work carried out by contractors must be authorised by Company management.
