INCIDENT ALERT

ALERT STATUS: Normal
DATE ISSUED: 07/04/2020 13:06:17
INCIDENT No: 02556

Leading edge working and fall arrest

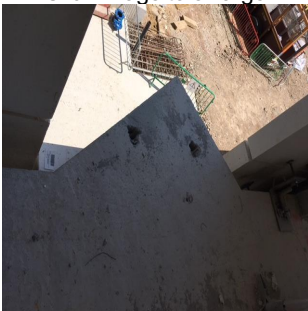
Internal view

An operator was working on a leading edge at Level 01 drilling remedial holes in the RC slab edge. The operative left the exclusion zone to retrieve dust suppression equipment. When he returned, he failed to clip back on to the anchor point before resuming work.

By failing to clip back on the operator exposed himself to the risk of a serious fall. The two images show the the area he was working on from the inside and outside.

- Toolbox talk provided to all operatives working on site in relation to working at height and the correct use of fall arrest equipment.
- 'STOP' campaign training provided to all operatives by principal contractor.
- Operatives to work in pairs 'buddy system' when working at height or carrying out high risk activities.
- Work at height permit system introduced.

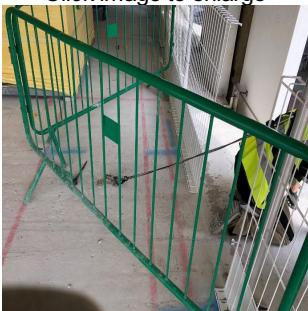
Image of operator clipped on
