Near Miss - Falling Object

LOCATION: ASPHALT/COATING PLANT
ACTIVITY: MAINTENANCE & HOUSEKEEPING
SUB ACTIVITY: N/A

ALERT STATUS: Normal
DATE ISSUED: 12/08/2020 10:46:56
INCIDENT No: 02566

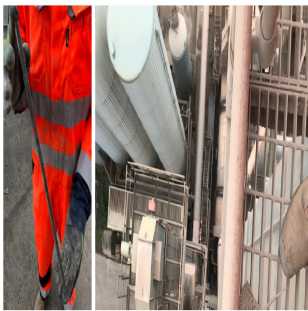
When the Fitter came to adjust the plate a sliver of metal fell through an open mesh and landed directly below on a platform where an operative was performing a greasing task close by.

Had the strip of Hardox steel plate struck the employee, there would have been a potential for serious injury.

- The off-cut fell through open mesh flooring at height, missing an operative by 1 metre.
- The Fitter did not advise site Management of the task change but proceeded anyway.
- RAMS controls became ineffective as a result.
- Permit to Work - Hot works became ineffective

- Fitter re-inducted and trained in the process to follow.
- Review of contractual relationship with fitting contractor.
- Local Management re-trained in the Risk Assessment process.
- Implementation of a mid-task checklist for supervisory staff to carry out and audit checks during completion.
