# INCIDENT ALERT

**LOCATION:** ASPHALT/COATING PLANT  
**ACTIVITY:** MAINTENANCE & HOUSEKEEPING  
**SUB ACTIVITY:** N/A

**ALERT STATUS:** Normal  
**DATE ISSUED:** 12/08/2020 10:46:56  
**INCIDENT No:** 02566

**Near Miss - Falling Object**

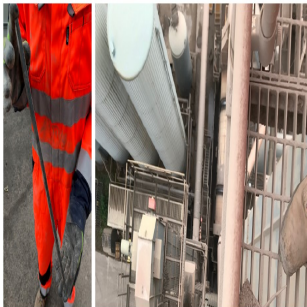
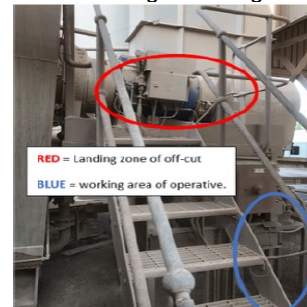
During a maintenance task on a piece of fixed plant, a Fitter was replacing a steel wear plate at the top of an aggregate elevator at a height of 33 metres.

When the Fitter came to adjust the plate a sliver of metal fell through an open mesh and landed directly below on a platform where an operative was performing a greasing task close by.

Had the strip of Hardox steel plate struck the employee, there would have been a potential for serious injury.

- The RAMS for the task noted cutting the steel plate at ground level, and not at height.
- The task changed during the activity and not been noted on the Risk Assessment.
- No cordoned zone was established below when the task changed and no checks made by the fitter.
- The off-cut fell through open mesh flooring at height, missing an operative by 1 metre.
- The Fitter did not advise site Management of the task change but proceeded anyway.
- RAMS controls became ineffective as a result.
- Permit to Work - Hot works became ineffective

- Fitter re-inducted and trained in the process to follow.
- Review of contractual relationship with fitting contractor.
- Local Management re-trained in the Risk Assessment process.
- Implementation of a mid-task checklist for supervisory staff to carry out and audit checks during completion.
