## INCIDENT ALERT

Normal  
04/04/2011  
00287

**Excavator Crush**

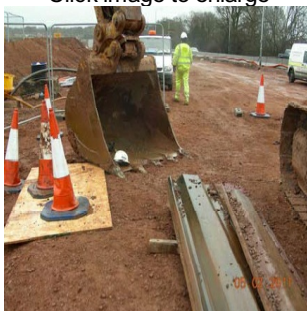
**Bucket**

An incident occurred recently within one of our group companies where a groundworker was trapped between the bucket and the track of a 35 tonne excavator. The operative was trapped just below the left knee, and tragically after multiple operations had to have his lower left leg amputated.

The principal causal factor was when the plant driver was climbing back into his cab following a conversation with the injured person, his coat snagged the slew/dipper arm control, and without realising that his coat was caught, he activated the "dead mans handle".

The excavator was 'ticking over' in idle mode, as he climbed in but the machine was set in 'high revs'. This deactivation of the safety device caused the machine bucket to travel at high speed in the direction dictated by the snagged control lever.

At that very moment the IP was walking between the bucket and track of the machine. This was so he could continue a conversation with a third party who had arrived at the scene just before the incident, he became trapped between the bucket and the track.

Plant must be turned off when the operator exits the cab.

Managers of plant operations should review the start up procedures of plant items, in particular, thought should be given to a methodical approach to the start up of plant, this will allow the operator time to ensure the hazard area of the plant is clear of persons on the ground. Engaging 'low revs' would be part of this process.

Segregation of all pedestrians and plant must be reviewed.

Tool Box Talks, task briefings, STARRT talks or any work related conversations should be undertaken away from plant items in a safe place.
