INCIDENT ALERT

CEMENT PLANT
TRANSPORT / DELIVERY
PRODUCT DELIVERY

Fall from Tipper

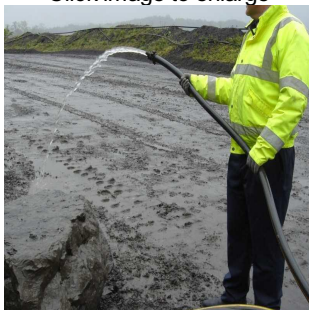
Picture 1: Pump Inoperative

On inspection, the water pressure at the wash station was not sufficient to allow the 'jet' of water to reach the full length of a tipper (picture No:1) and this may have been the reason why the wash station was not used. Further investigation found that the wash station boost pump had tripped, once reset the station operated as intended (picture No:2).

The supervision and control of contractors is paramount and where local rules are in place they must be enforced and policed at all times. All equipment must be suitable & sufficient for the task that it is intended.

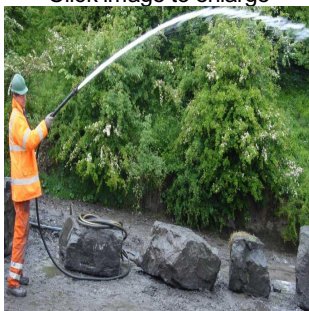
Picture 2: Pump Working
