# Fall from Tipper

CEMENT PLANT  
TRANSPORT & LOGISTICS / DELIVERY  
PRODUCT DELIVERY

ALERT STATUS: Normal  
DATE ISSUED: 25/06/2011  
INCIDENT No: 00290

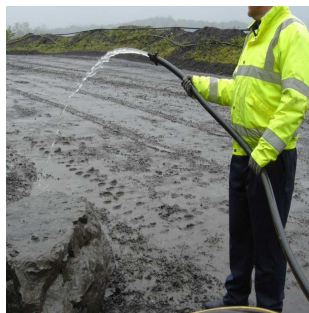
Picture 1: Pump Inoperative

On inspection, the water pressure at the wash station was not sufficient to allow the 'jet' of water to reach the full length of a tipper (picture No:1) and this may have been the reason why the wash station was not used. Further investigation found that the wash station boost pump had tripped, once reset the station operated as intended (picture No:2).

The supervision and control of contractors is paramount and where local rules are in place they must be enforced and policed at all times. All equipment must be suitable & sufficient for the task that it is intended.

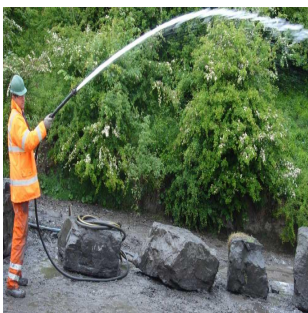
Picture 2: Pump Working
