INCIDENT ALERT

ALERT STATUS: Normal
DATE ISSUED: 05/07/2011
INCIDENT No: 00291

Chassis Failure Komatsu 350 Dumper

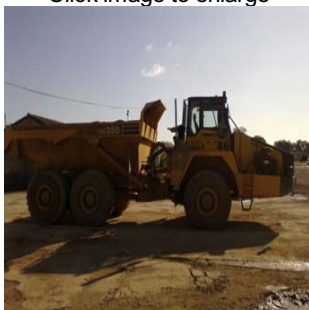
Plant

An inspection of the dumper was undertaken and it was discovered that the near-side tractor unit chassis had a large split running through it. This made the vehicle un-safe and it was immediately taken out of service.

- Pressure wash and conduct a thorough chassis inspection of all Komatsu HM 350 and HM400 dumpers.
- A known indicator of this problem is a widening of the gap where the battery box abuts the wheel arch.
- Where there is any doubt contact John Taylor, Product Support Manager at Marubeni Komatsu, who will arrange for a service engineer to visit. (Editors note: Other company's may need to make their own arrangements for a specialist inspection).

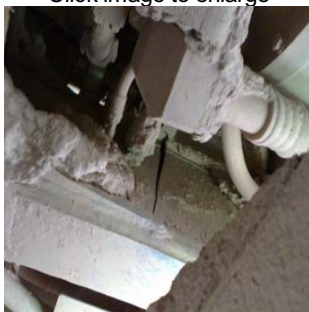
Split Chassis
