Chassis Failure Komatsu 350 Dumper

ALERT STATUS: Normal
DATE ISSUED: 05/07/2011
INCIDENT No: 00291

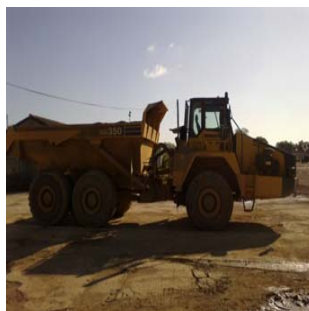
Plant

An inspection of the dumper was undertaken and it was discovered that the near-side tractor unit chassis had a large split running through it. This made the vehicle un-safe and it was immediately taken out of service.

- Pressure wash and conduct a thorough chassis inspection of all Komatsu HM 350 and HM400 dumpers.
- A known indicator of this problem is a widening of the gap where the battery box abuts the wheel arch.
- Where there is any doubt contact John Taylor, Product Support Manager at Marubeni Komatsu, who will arrange for a service engineer to visit.
(Editors note: Other company's may need to make their own arrangements for a specialist inspection).
