Fall into Unguarded Opening

AGGREGATE DREDGER
ACCESS & EGRESS & WORKING AT HEIGHT
N/A

ALERT STATUS: Normal
DATE ISSUED: 16/01/2012
INCIDENT No: 00321

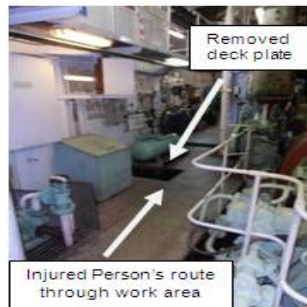
The Engineer who was fault finding briefly went below the removed deck plate to trace an air line. The Injured Person, who had completed his task, was returning his tools to the engine room workshop, via the area where the deck plate had been removed.

The Engineer who had been below the plates for about a minute then climbed out and turned to see the IP carrying the tools approaching him and the unguarded opening in the deck. The Engineer immediately challenged the approaching IP by putting his hand up to warn / stop him from proceeding towards the hazardous location where the plate had been removed (Note: ear protection was being worn in the engine room).

Unfortunately the IP failed to acknowledge the warning, as he was not looking where he was

going, and subsequently stepped into the unguarded opening, falling to the deck; he did manage to stop himself from falling completely into the opening. This resulted in the IP requiring hospital treatment, where he was treated for fractures to his lower right leg and cuts and bruising to his left leg and arm.

Incident Location

This incident demonstrates the importance of always putting physical barriers / guarding in place, with appropriate warning signage, prior to any plates, gratings or covers etc. being removed where there is a potential risk of falling into an unprotected opening, even for short periods.

- While the Engineer was only under the plates for a very short period and did not leave the work location, he failed to look after himself and his colleagues by effectively physically guarding the work area and having the appropriate signage in place warning of the hazards at that location (E.G.

“NO UNAUTHORISED ACCESS - FLOORING REMOVED”).

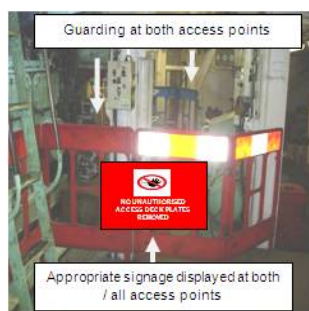
Properly Guarded Access
