INCIDENT ALERT

Normal
02/03/2012
00326

Excavator Incident

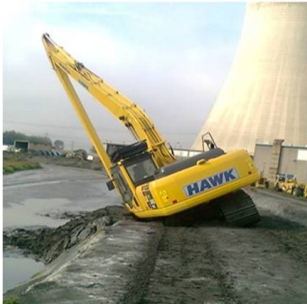
Image 1

A request was made by company staff to form a gap in the bund wall in order for the excavator to run on the hardcore. The site management rejected this idea as too complicated. After assessing the PFA road on foot, the task of moving the excavator began at which point the excavator sank into the made up road. The quick thinking operator moved the grab arm preventing the excavator tipping into the lagoon.

The road had only been geotechnically assessed as stable for mobile plant traffic under dry conditions: Are all haul roads assessed under all foreseeable conditions by a competent person?

There was no bund protection between the excavator and the water: Are all haul roads near water protected by a bund wall, which should be half the height of the diameter of the largest wheel or 1.5 metres, whichever is the greater?
