INCIDENT ALERT

LOCATION: CEMENT PLANT
ACTIVITY: MAINTENANCE & HOUSEKEEPING
SUB ACTIVITY: N/A

ALERT STATUS: Normal
DATE ISSUED: 03/09/2012
INCIDENT No: 00337

Sudden Fluid Coupling Failure

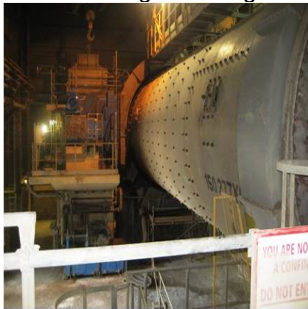
The cement mill contains 380 tonnes of steel balls. Some months ago an additional manually operated water lance was installed to further improve the mill temperature control. The existing cooling water lances are all automatically controlled.

The mill was shutdown on the day prior to the incident and a verbal request made for the water feed to be turned off. The following day water was seen coming from the cement mill outlet – the mill now had a mix of water, cement and grinding media within it. A decision was made to turn the mill using the barring drive to break up the accumulated material.

Cement mill with barring drive platform

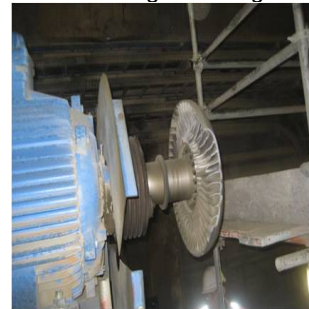
Shortly after commencing the inching operation the barring drive was stopped due to excessive load. Unfortunately the automatic shaft brake failed to hold the weight of the out of balance load causing the mill to drive the gearbox and fluid coupling in reverse. The gearing resulted in the coupling going in to over-speed and a loud “whooshing” sound was heard from the fluid coupling immediately prior to failure.

Remains of fluid coupling after failure

Immediate cause - An uncontrolled reversal of the mill resulting in excessive pressure due to overspeed within the fluid coupling.

Root Cause – The operation of the manual cooling water lance had not been adequately assessed when the modification was made. – Management of change.

- Develop and implement a straightforward and practical management of change procedure.
- Review and “HAZOP” study other similar installations where fluid couplings are installed in the drive train. Consider installing alternative drive arrangements (e.g. soft starts, inverters) and review the position of controls in relation to drive trains.
