Sudden Fluid Coupling Failure

LOCATION:	CEMENT PLANT	ALERT STATUS:	Normal
ACTIVITY:	MAINTENANCE & HOUSEKEEPING	DATE ISSUED:	03/09/2012
SUB ACTIVITY:	N/A	INCIDENT No:	00337

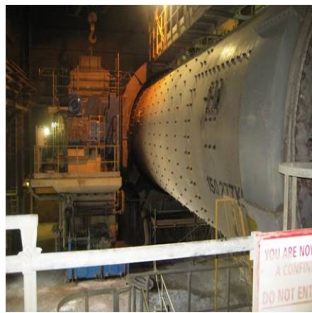
Cement mill with barring drive platform

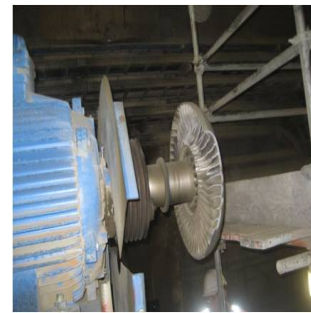
Shortly after commencing the inching operation the barring drive was stopped due to excessive load. Unfortunately the automatic shaft brake failed to hold the weight of the out of balance load causing the mill to drive the gearbox and fluid coupling in reverse. The gearing resulted in the coupling going in to over-speed and a loud “whooshing” sound was heard from the fluid coupling immediately prior to failure.

Remains of fluid coupling after failure

Immediate cause - An uncontrolled reversal of the mill resulting in excessive pressure due to overspeed within the fluid coupling.

Root Cause – The operation of the manual cooling water lance had not been adequately assessed when the modification was made. – Management of change.

- Develop and implement a straightforward and practical management of change procedure.
- Review and “HAZOP” study other similar installations where fluid couplings are installed in the drive train. Consider installing alternative drive arrangements (e.g. soft starts, inverters) and review the position of controls in relation to drive trains.
