Operator bruises hand due to release of stored energy in operation to free stuck davit (lifting device) - BMAPA Alert

LOCATION: AGGREGATE DREDGER
ACTIVITY: MAINTENANCE & HOUSEKEEPING
SUB ACTIVITY: N/A

ALERT STATUS: Normal
DATE ISSUED: 06/10/2020 10:33:40
INCIDENT No: 03570

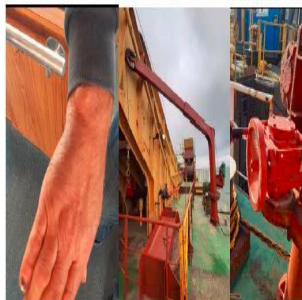
While moving a stuck lifting davit which was wedged under a fire main pipe with the use of a chain block onboard a UK marine aggregate dredger, the slewing wheel hit the IP's hand causing bruising when the davit arm released.

To free the boom of the davit a chain block was rigged so the boom would be pulled downward and outward. While the boom was loaded up by the chain block the boom came free from under the pipe and moved suddenly outboard. At this point the slewing wheel spun round where upon the handle of the wheel struck the IP on the back of the hand.

Prior to this incident the discharge boom was moved past its normal operating parameters at a wharf to facilitate discharge. The hazards involved had not been clearly identified as the boom conveyor struck the davit and pushed the davit underneath the fire main where it became stuck. No formal Risk Assessments were in place for either the movement of the discharge boom to facilitate discharge beyond normal operating parameters, or the subsequent freeing of the davit back into its normal position.

A formal RA may have identified the potential of hitting the davit in the first place and subsequently the release of stored energy when the boom was released by the chain block.

The POWRA must only be used for low risk tasks and there was sufficient time to plan and complete the RA for the movement of the davit which occurred 4 days after it was wedged under the fire main.

- When conducting Risk Assessments ensure all hazards are clearly identified especially when identifying the potential of stored energy being present.
- Any operational equipment being moved beyond its normal operating parameters must be fully risk assessed and approved by the Ship Manager beforehand, except if for "preservation of life", the ship or the environment under the master's discretion.
