Fatal 1 - BMAPA Alert - Stored energy/Stress in a damaged hull

LOCATION: AGGREGATE DREDGER
ACTIVITY: MAINTENANCE & HOUSEKEEPING
SUB ACTIVITY: N/A

ALERT STATUS: Normal
DATE ISSUED: 30/10/2020 11:16:10
INCIDENT No: 03573

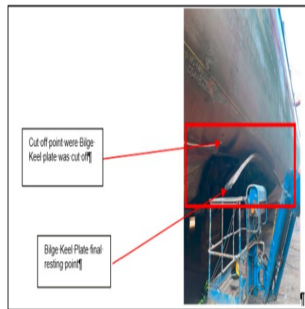
A contractor working in a UK ship repair yard was removing a section of damaged bilge keel by oxy acetylene burning. When reaching the end of his cut the stored energy / stress in the deformed bilge keel caused the plate to release downwards then upwards violently hitting the contractor on the chest, shoulder, jaw and head.

Fortunately, this did not end up with any life changing major injuries but it could have and it was completely avoidable if a task specific risk assessment had been completed.

- All tasks in a repair yard should be fully risk assessed to identify all risks present and not presume or assume personnel (including contractors/sub-contractors) understand all risks associated with tasks.

- Personnel are required to sign off the risk assessment for the task to confirm they have read and understood.
- Repair yards to ensure they have risk assessments in place for “Removing Material under stored energy”

- One-to-one briefing of workers by supervisor or manager to ensure they understand the method statement and associated risk controls.
- Any potential stored energy release tasks must be classed as high risk

- Specific control points are to be put in place to remove damaged hull plating in small sections with all plating / frames under stress marked up with cut lines / cut sequence

- Any plate being removed must be supported / restrained to control any release of stored energy
- Daily project meetings must ensure all high-risk activities are discussed and all associated work is properly planned.
