## INCIDENT ALERT

**LOCATION:** AGGREGATE DREDGER  
**ACTIVITY:** ACCESS & EGRESS & WORKING AT HEIGHT  
**SUB ACTIVITY:** N/A

**Operator sustains grazed/bruised back from contact with scaffolding -non-treatment injury - BMAPA Alert**

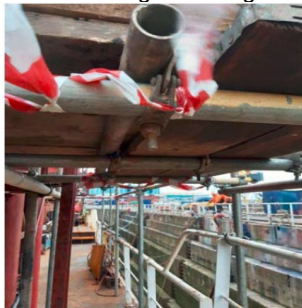
A UK marine aggregate dredger was undergoing its annual dry dock. Scaffolding had been erected in the vicinity of the aft screening tower to facilitate its removal. The scaffolding was erected across the starboard side walkway which restricted the walkway, with the scaffolding platform only being 1.5m above the spillway. The erected scaffolding had red and white hazard tape applied to highlight the low height of the scaffolding and the protruding scaffolding clips whilst waiting on delivery of protective foam.

The IP transited this walkway for general access to the engine room and in doing so, whilst crouched down, impacted his back on the protruding scaffolding clips. This caused a small abrasion and bruise on the left side under the shoulder.

It has been identified that there was inattention to immediate surroundings as the scaffolding was highlighted with hazard tape.

- Staff to discuss the importance of paying attention to their immediate surroundings and the importance of making informed decisions where normal access routes may be restricted during maintenance periods.
- Ensure scaffolding has been fully completed, including foam protection fitted before signed off and used as a thoroughfare.
