INCIDENT ALERT

LOCATION:	LIME & SLAG PLANTS	ALERT STATUS:	Normal
ACTIVITY:	TRANSPORT / DELIVERY	DATE ISSUED:	03/02/2021 11:43:19
SUB ACTIVITY:	PRODUCT DELIVERY	INCIDENT No:	03584

Fatal 5 - Operator struck by flailing pipe when making delivery

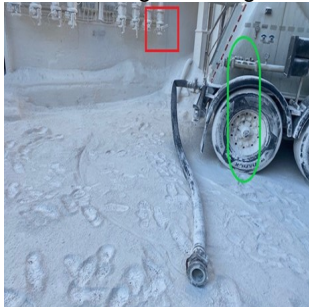
Image 1

During the discharge of material from a Feldbinder belly tank into a silo inlet, the pressurised pipe lost its connection on the receiving end inlet. The pipe was flailing, and material was blowing out.

The vehicle operator then proceeded to return to the hazardous area at the rear of the tank to shut off the pinch valves. Visibility was poor due to material blowing out of the pipe. It was at this stage the flailing pipe struck the vehicle operator's leg which caused bruising and required first aid treatment. This resulted in a lost time accident and a RIDDOR reportable over 3-day injury.

Picture 1 shows the scene immediately after the incident. The green oval is the location where the vehicle operator was initially positioned during discharge, and the red box is the silo inlet the pipe was attached to.

Root cause of the vehicle operator being struck by pipe was the vehicle operator returning to rear of tanker. If the vehicle operator had let the tank lose pressure and stayed clear of the hazardous area, they would not have come into contact with the flailing pipe.

- Risk assessment and safe system of work reviewed
- Refresher training delivered to drivers focusing on correct selection of pipe.
- Whip check safety cables to be fitted. (*only if the anchoring point on the fixed end is deemed secure enough to take the force of a flailing pipe.)

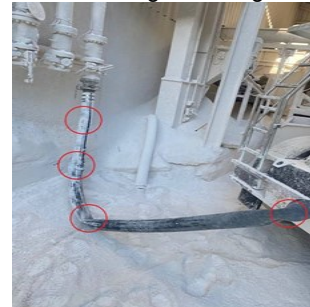
Image 2

Picture 2 shows how the pipe was reattached post incident following the correct working method. No issues were found with the coupling and the couplings were in good condition.

Following the incident a review established the following: Picture 2 shows kinks in the pipe. Kinks restrict the flow of product causing the pipe to move and jump about resulting in excessive vibrations on all couplings through surges of material in the pipe. The material should have a steady state of flow.

The root cause of the pipe coming off was the vehicle operators pipe selection. With the correct selection of pipe, the material would have a steady rate of delivery and not cause excessive vibrations.
