Fatal 5 - Operator struck by flailing pipe when making delivery

LOCATION:	LIME & SLAG PLANTS	ALERT STATUS:	Normal
ACTIVITY:	TRANSPORT & LOGISTICS / DELIVERY	DATE ISSUED:	03/02/2021 11:43:19
SUB ACTIVITY:	DELIVERING ADMIXTURES & CHEMICALS	INCIDENT No:	03584

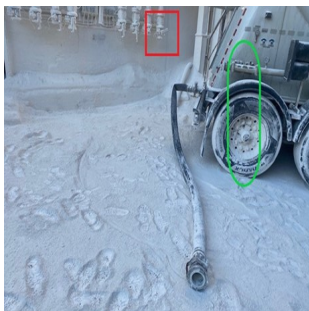
Image 1

The vehicle operator then proceeded to return to the hazardous area at the rear of the tank to shut off the pinch valves. Visibility was poor due to material blowing out of the pipe. It was at this stage the flailing pipe struck the vehicle operator's leg which caused bruising and required first aid treatment. This resulted in a lost time accident and a RIDDOR reportable over 3-day injury.

Picture 1 shows the scene immediately after the incident. The green oval is the location where the vehicle operator was initially positioned during discharge, and the red box is the silo inlet the pipe was attached to.

Root cause of the vehicle operator being struck by pipe was the vehicle operator returning to rear of tanker. If the vehicle operator had let the tank lose pressure and stayed clear of the hazardous area, they would not have come into contact with the flailing pipe.

- Risk assessment and safe system of work reviewed
- Refresher training delivered to drivers focusing on correct selection of pipe.
- Whip check safety cables to be fitted.(*only if the anchoring point on the fixed end is deemed secure enough to take the force of a flailing pipe.)

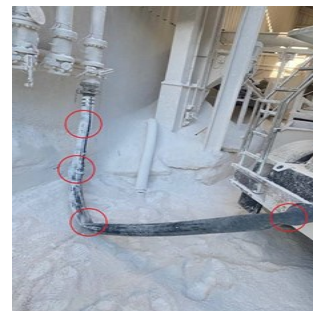
Image 2

Picture 2 shows how the pipe was reattached post incident following the correct working method. No issues were found with the coupling and the couplings were in good condition.

Following the incident a review established the following: Picture 2 shows kinks in the pipe. Kinks restrict the flow of product causing the pipe to move and jump about resulting in excessive vibrations on all couplings through surges of material in the pipe. The material should have a steady state of flow.

The root cause of the pipe coming off was the vehicle operators pipe selection. With the correct selection of pipe, the material would have a steady rate of delivery and not cause excessive vibrations.
