## INCIDENT ALERT

**ALERT STATUS:** Normal  
**DATE ISSUED:** 30/11/2021 18:07:45  
**INCIDENT No:** 03599

**Operator injured by arm rest on CAT 980**

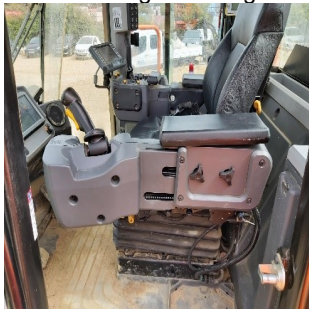
**Armrest down**

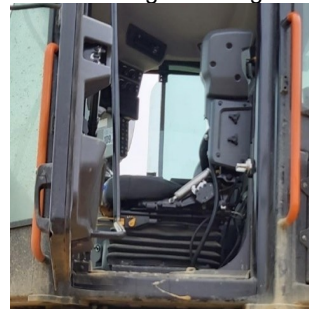
On this machine the arm rest unit and joystick control are raised and lowered to allow operator access and egress from the machine. A piston ram is connected to the seat and the unit to assist with the lifting and lowering, similar manner to operating a car boot.

**Armrest in up position to allow access**

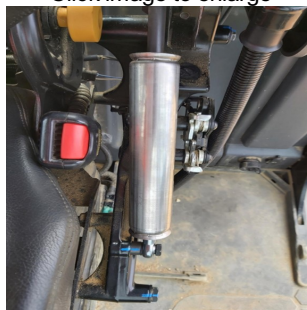
As the IP was lowering the unit back into the horizontal position, it become stuck. As the IP investigated the cause, the unit released and fell trapping the IPs finger.

An investigation identified that the connecting pin attaching the piston ram to the seat had sheered.

**Faulty piston**

At the time of the incident, the machine was three months old. Two other CAT 980s (delivered at same time) were also found to have a similar issue with the arm rest. All arm rests have now been modified in accordance with manufacturers instruction.

1. If something does not work as expected, it should be treated it with extreme caution as it could be in an unsafe condition and not react as expected. Ensure body parts are kept clear from potential nip points.
2. Arrange with supplier for inspection to be undertaken of CAT 980 armrest.
