Operator injured by arm rest on CAT 980

ALERT STATUS: Normal
DATE ISSUED: 30/11/2021 18:07:45
INCIDENT No: 03599

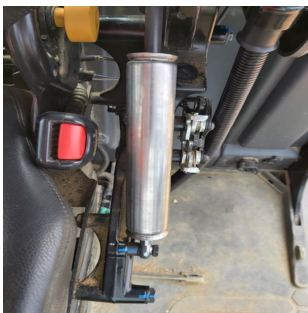
An investigation identified that the connecting pin attaching the piston ram to the seat had sheered. At the time of the incident, the machine was three months old. Two other CAT 980s (delivered at same time) were also found to have a similar issue with the arm rest. All arm rests have now been modified in accordance with manufacturers instruction.

Faulty piston

2. Arrange with supplier for inspection to be undertaken of CAT 980 armrest.
