Fatal 5 - Lifting eyebolt failure

LOCATION: QUARRY
ACTIVITY: LIFTING
SUB ACTIVITY: NO SUB ACTIVITY AVAILABLE

ALERT STATUS: Normal
DATE ISSUED: 27/01/2022 11:42:49
INCIDENT No: 03604

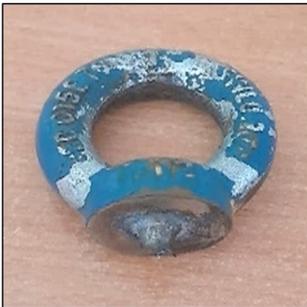
When the motor and gearbox were lifted the eyebolt failed (snapped off at the collar) and the load fell 750mm onto the plant walkway.

The lifting eyebolt was designed for lifting the motor only, with a safe working load of 300kgs. The combined weight of the motor and gearbox was 400kgs (eyebolt/load was therefore 100kgs overloaded).

The weight of the gearbox offset the load, preventing a balanced vertical lift and creating lateral shear force on the eyebolt. The eyebolt is designed for lifting the motor vertically.

Sheared eyebolt

- All lifting operations must be properly planned by a competent person, appropriately supervised and carried out in a safe manner – in accordance with LOLER Regulations – Regulation 8
- The use of a mobile crane and/or alternative lifting attachments (slings, etc.) should be considered when developing a Lift Plan.
- **NEVER** exceed the safe working load of lifting equipment. If something changes during the job – remember to **STOP** and reassess the risks.

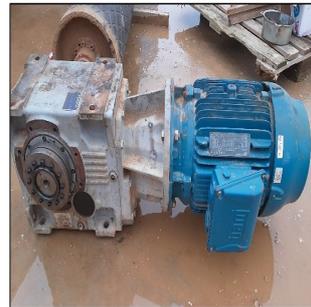
The motor shaft was seized onto the gearbox preventing the two items being split and lifted separately.

Motor and gearbox (eyebolt socket on motor)
