# Over Turned 1 tonne Dumper

LOCATION:	CONSTRUCTION/DELIVERY SITE	ALERT STATUS:	Normal
ACTIVITY:	PRODUCTION AND PROCESSING	DATE ISSUED:	24/05/2013
SUB ACTIVITY:	ASPHALT & COATED STONE	INCIDENT No:	00365

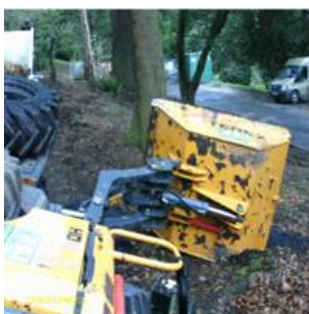
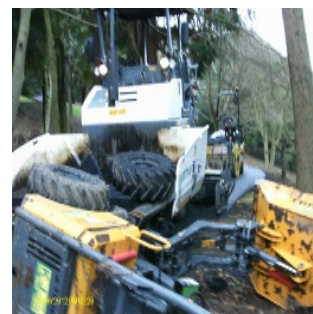
As one of the 1 tonne dumpers had tipped its load of asphalt into the paver hopper, the dumper driver reversed away from the paver (across a gradient), with the dumper bucket still in it's elevated position: and the dumper overturned due to the raised centre of gravity and narrow wheel track. Fortunately, the driver was not injured during the incident although he was slightly shaken.

Over turned dumper

The gradients were measured during the investigation and were found to vary between 1:5 to 1:15, running both along and across the footpath. It also became apparent that control measures identified during previous dumper incident investigations had not been implemented.

- The company has banned all 1 tonne skip loader dumpers from its operations and alternatives are being sought e.g. tracked 1.5 tonne dumpers, JCB 2CX, 3 tonne dumper etc.
- The gradients on site must be measured prior to work commencing, and checks must be made with the plant hire companies and operator's hand books, to make sure that the gradients do not exceed the plants' safe operating capabilities.
- Adequate control measures must be developed and included in the Site/Task specific Risk Assessment, added to the Job Briefing Sheet/Safe System of Work and adequately communicated to all personnel on site.
- If at any time, anyone on site is of the opinion that the work being undertaken is unsafe, they should raise their concerns with their

supervisor/line manager and seek to find a safer alternative method of working.
