# Battery Explosion

LOCATION:	CEMENT PLANT
ACTIVITY:	MAINTENANCE & HOUSEKEEPING
SUB ACTIVITY:	N/A

ALERT STATUS:	Normal
DATE ISSUED:	01/08/2013
INCIDENT No:	00368

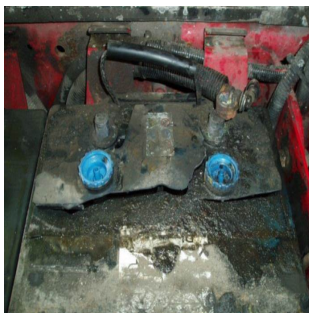
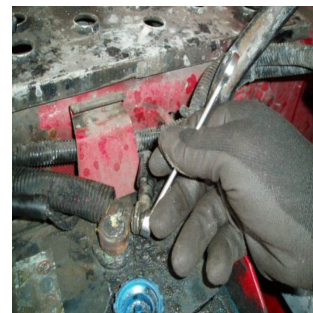
An LGV vehicle battery top exploded when the hydrogen gas it was venting, was ignited by sparks, caused by a spanner accidentally touching earth.

What happened: A contractor was carrying out a modification to a catwalk. As this work involved welding to the chassis, the battery was disconnected. Once the work was completed the battery was reconnected, and the spanner accidentally touched the chassis, causing an arc. This in turn ignited the hydrogen venting from the battery, causing it to explode.

It would not be expected for a battery to give off gas when not being charged, however in this instance the vehicle was started and moved into the workshop, this will have drained the batteries and caused the vehicle to start charging.

Once in the workshop the positive (+) terminal was disconnected, and the batteries were covered with rags to protect them from welding/cutting & grinding. It is possible that the rags did not allow the gas to dissipate and built up during the time it took to carry out the modification. Never cover the batteries with rags, should the batteries need protection, replace the cover, or remove them.

Disconnecting/reconnecting the positive (+) terminal, of the battery is not considered the correct method, as any contact with an earth will cause a spark.

accidental touching of the chassis would not result in a short circuit. Always remove the negative (-) terminal first!
