Fatal 5 – Operator was struck in face by tool that fractured his cheek whilst he was clearing material in pre-heater tower

LOCATION: CEMENT PLANT
ACTIVITY: MAINTENANCE & HOUSEKEEPING
SUB ACTIVITY: KILNS

ALERT STATUS: Normal
DATE ISSUED: 17/01/2024 20:07:03
INCIDENT No: 03691

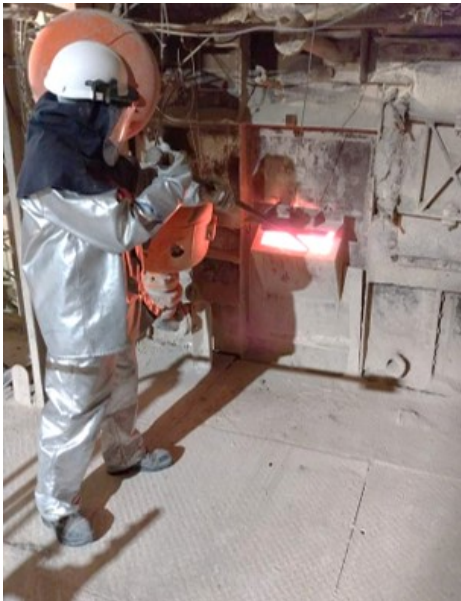
An experienced preheater tower operative (employee) was undertaking his normal duties to clear a preheater door of build-up to allow for the safe execution of water jetting activities within the preheater tower.

Whilst clearing the door with the specifically designed tool, a lump of build-up fell within the PHT duct and hit the bar, causing the end that the injured person (IP) was holding to deflect towards his face, resulting in a fracture to the cheek bone.

- No specific action has been identified to reduce the likelihood of this occurrence. The preheater process was operating in steady state. The cleaning activity was completed as per procedure.
- Remote or robotic equipment that would reduce the need for human interaction in this task would eliminate the risks associated. Whilst technology is advancing rapidly, there is currently no remote or robotic solution available on the market that would work in the high temperature environment of the pre-heater ducting.
- Due to the fundamental design of this preheater tower (2 stage with twin double deflectors), plus 80% + alternative fuel usage, it is acknowledged this increases the risk for buildup and material falls in the PHT.
