Fatal 5 - Gasket failure at asphalt plant resulting in bitumen spill

LOCATION: ASPHALT/COATING PLANT
ACTIVITY: MAINTENANCE & HOUSEKEEPING
SUB ACTIVITY: ASPHALT & COATED STONE

ALERT STATUS: Normal
DATE ISSUED: 21/10/2024 15:42:42
INCIDENT No: 04839

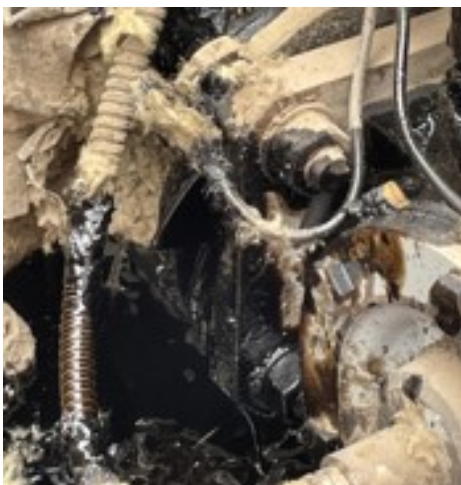
Pipework - The pipes connected to the pump were installed at an angle, it is likely that this complicated the installation of the sealing gaskets during the pump's fitting. Additionally, the pump flange was square while the pipe flange was round, and a portion of the flange had been removed to accommodate the bolts on the side where the failure occurred.

Gasket - The gasket appeared to have been 'pinched' during installation, resulting in a vulnerable area that permitted the gasket to split. The image shows the location of the failed gasket.

Assessing the existing condition of equipment, ensuring components are compatible, standardisation of equipment where practical, considering the consequences if a failure was to occur.

- Review bitumen systems to determine if there are water or air pipes situated at ground level that may come into contact with bitumen in the event of a spillage from any section of the system.
- Is the bitumen pump adequately shielded to prevent the outward spraying of bitumen?
- Are all flanges enclosed to prevent bitumen spray in the event of a seal failure?
- Are relevant inspections in place for bitumen systems?
- Are there signs of leaking from pipework?
- It is essential to promptly address and repair any leaking bitumen pipework.
