**Gasket failure at an asphalt plant resulted in a bitumen spill. Some of the bitumen, which was at a temperature of circa 130 - 140 degrees, enveloped an airline that ruptured causing a spray of the bitumen.**

<b>LOCATION:</b>	<b>ASPHALT/COATING PLANT</b>	<b>ALERT STATUS:</b>	<b>Normal</b>
<b>ACTIVITY:</b>	<b>MAINTENANCE &amp; HOUSEKEEPING</b>	<b>DATE ISSUED:</b>	<b>21/10/2024 15:52:13</b>
<b>SUB ACTIVITY:</b>	<b>ASPHALT &amp; COATED STONE</b>	<b>INCIDENT No:</b>	<b>04840</b>

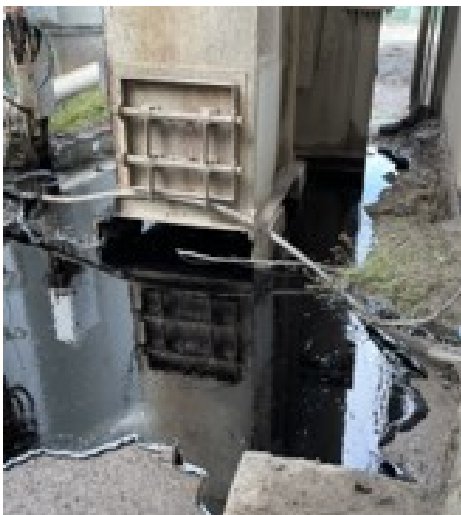
A failure in the bitumen trace heating system on an asphalt plant resulted in the pipework cooling. After the trace heating was repaired the pipework was brought back to the operating temperature. The plant was then started successfully, mixing 6 tonnes without any problems. However, as the manager passed by the bitumen system, he observed bitumen leaking beneath the pump cover box. He promptly notified the plant operator, leading to the shutdown of the equipment. It was also discovered that some of the bitumen, which was at a temperature of circa 130 - 140 degrees, had enveloped an airline that ruptured causing a spray of the bitumen. See full incident alert for more information.
