Fatal 5 - A buildup of hardened concrete, fell from height and narrowly misses a driver.

LOCATION: READYMIX OR MORTAR PLANT
ACTIVITY: MAINTENANCE & HOUSEKEEPING
SUB ACTIVITY: MIXERS

ALERT STATUS: Normal
DATE ISSUED: 11/09/2025 12:46:57
INCIDENT No: 04926

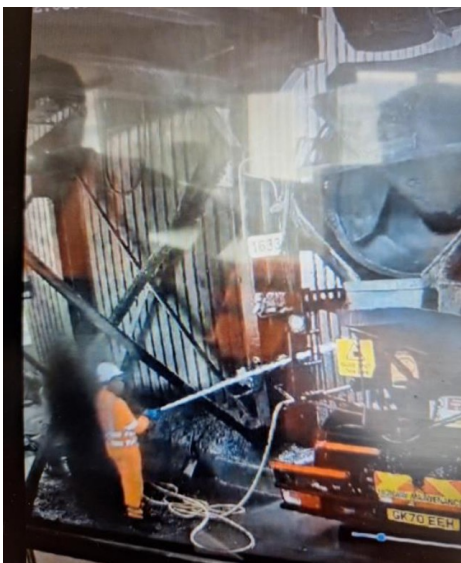
During the loading of a mixer truck the lump became loose, falling to the ground. The lump fell and landed inside an exclusion zone, however as the lump struck the ground, it broke into several large pieces, with some travelling outside the exclusion zone. Moments before the lump fell a driver had been standing outside the exclusion zone, adjacent to where the lump fell. Although the lump would not have hit him directly, there was potential for the broken pieces to have struck him on the back of the legs.

Image 1 - Driver standing outside exclusion zone washing his truck down

- Review cleaning regimes to minimize the buildup of material and the risk of lumps being dislodged and falling.
- Areas where there is a risk of material falling to be designated exclusion zones with barriers and warning signs displayed.
- Where access is required controls in place to protect against falling material.

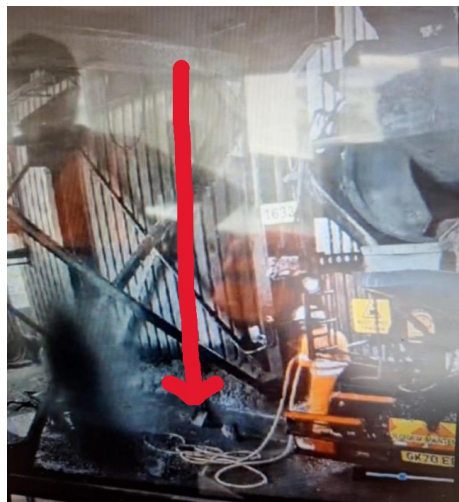
A lump of hardened concrete had built up on the mixer support structure of a concrete plant.

Image 2 - Build up fell the other side of the cross bracing, breaking into large parts and narrowly misses the driver
