# Contractor trapped his thumb during lifting operation and sustained fracture

**LOCATION:** CEMENT PLANT  
**ACTIVITY:** LIFTING  
**SUB ACTIVITY:** NO SUB ACTIVITY AVAILABLE

**ALERT STATUS:** Normal  
**DATE ISSUED:** 11/11/2025 18:06:37  
**INCIDENT No:** 04943

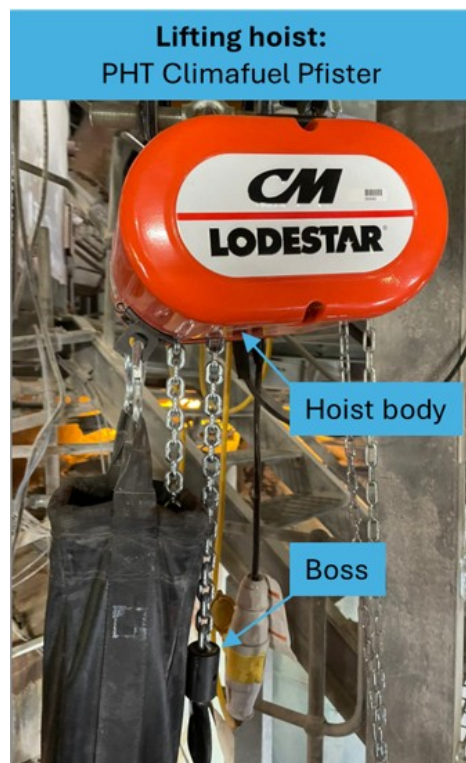
While operating a power hoist, a trained and experienced contractor momentarily trapped the tip of his left thumb between the hoist body and the boss above the hook.

The image on the left shows the boss whilst in a lowered position. The second image shows the boss in its upper trip position between the shoulders of the casing and illustrates how, despite the 'safety gap', it is still possible for the thumb to be nipped (the blue spot shows where the gloved thumb was caught). The final image shows the relative height of the beam and the limited space available.

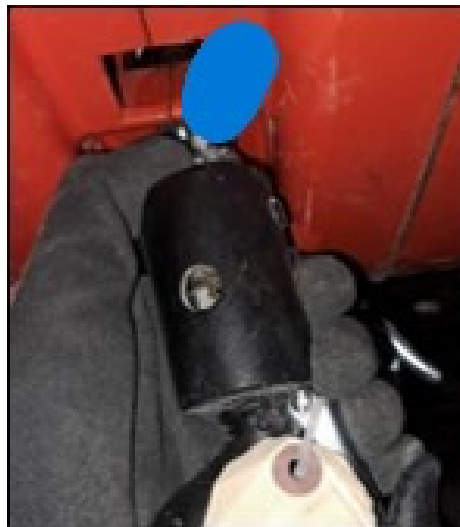
The injury occurred when the injured person (IP) attempted to manually guide the load by holding the hook during hoisting. A moments loss of concentration resulted in the IP's left thumb becoming trapped.

A contributing factor to the incident was the design of the lifting beam and hoist setup. Due to space constraints caused by surrounding equipment, the chain lift point cannot be centrally aligned with the trap door, requiring the IP to manually guide the load into position. Additionally, the hoist was mounted at head height (again due to space constraints), creating an accessible nip point between the hook and the casing.
