Fatal 3 - TRANSPORT - Mixer driver exposed himself to the risk of a serious fall whilst trying to clear a blockage on the pigs ear.

LOCATION:	READYMIX OR MORTAR PLANT	ALERT STATUS:	Normal
ACTIVITY:	MAINTENANCE & HOUSEKEEPING	DATE ISSUED:	07/12/2025 18:49:50
SUB ACTIVITY:	MIXERS	INCIDENT No:	04956

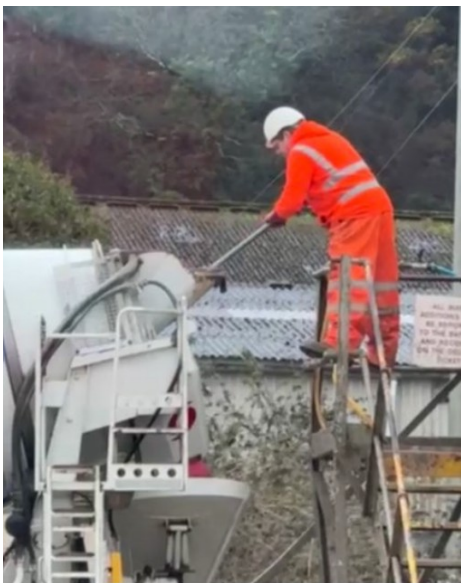
A driver was clearing a blockage from his pigs ear, and whilst doing so climbed onto the second rail of the slump stand railing to gain a better angle. By taking this action the driver had exposed himself to the risk of a fall and potentially serious injury.

- There was spillage built up by the slump stand that was preventing mixer trucks from getting close enough to the slump stand to easily clear blockages.
- The driver had not been fully inducted to site and not completed the comprehension test to ensure he understood it.
- Driver did not identify the hazards associated with completing the task that way and had not seen the RAMS for the activity.
- The RAMS for the activity did not adequately cover the activity.
- There is no standard procedure for clearing a blockage in the pigs ear within the company.

- The spillage was cleared at the base of the slump stand and a high-powered hose installed to keep the area clean.
- The risk assessments were reviewed and delivered out to drivers.

- Ensure individuals when inducted at sites are taken through the comprehension test.
- Ensure any individuals undertaking tasks are aware of and understand the relevant risk assessment.
- Review risk assessments around clearing blockages in pigs ears and ensure that they adequately cover the activity.
