# MOBILE PLANT - Fatal 5 - Tractor loses wheel on quarry haul road.

**ALERT STATUS:** Normal  
**DATE ISSUED:** 12/06/2026 00:11:32  
**INCIDENT No:** 04977

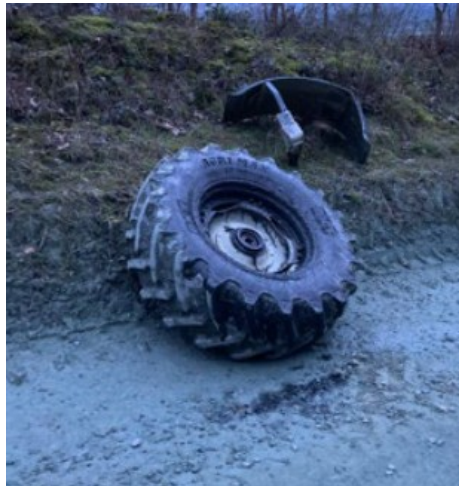
A New Holland tractor was travelling up the incline on a quarry haul road when the wheel hub failed causing the wheel to detach from the tractor.

An investigation identified the following root causes

- Improper extension of service life of equipment
- The hub assembly had operated for many years without inspection
- No formal checks in line with original equipment manufacturer (OEM) recommended service intervals
- Servicing had been moved in house with improper management of change.

- Service interval on Checkproof for tractor to include OEM specific checks.
- Identify all assets over 15 years old for immediate life extension inspections.
- Develop component life cycle matrix auxiliary equipment and implement annual health check on Checkproof.
- Service on Checkproof to include full-service document and annual health check document, with person responsible to receive alert.
