CUSTOMERS EMPLOYEE STRUCK ON HEAD BY TAIL BOARD

ALERT STATUS:	Normal
DATE ISSUED:	27/07/2006
INCIDENT No:	00096

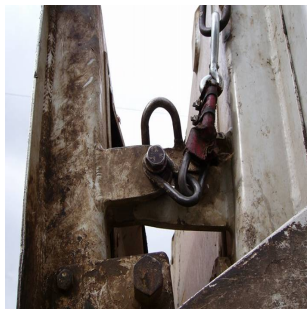
- 1.The retaining hasp for the tail board was not fully operational.
- 2.The retaining chain had a faulty carabineer, which was twisted making it difficult to fully secure.
- 3.All those involved in the incident were aware of the hazards from the tail board, yet continued with the job despite concerns over the safety hasp and chain.

Correct operation of safety hasp and securing chain

- 1) The safety devices on tipper lorries must be maintained in a fully working and operational state by the owners.
- 2) The safety hasp and the safety chain must be properly engaged prior to any work being undertaken.
- 3) Where there is any concern over the security of the safety devices on any lorry, the job must not continue until the devices can be correctly and fully engaged.
