Atlantic Alliance Conference

September 25, 2008

Analyzing the USA Numbers

--Root Causes--Best Practices--

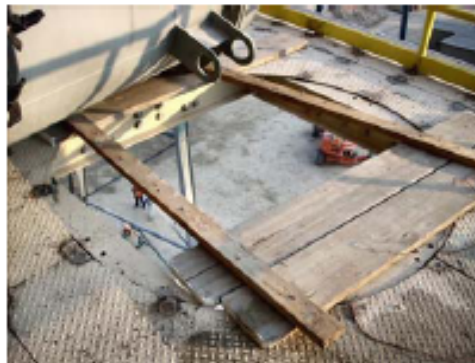
Fatality #29 - October 25, 2007
Fall of Person - California - Cement
Riverside Cement Company - Oro Grande Quarry

METAL/NONMETAL MINE FATALITY - On October 25, 2007, a 19 year-old contractor ironworker with 20 weeks of experience was fatally injured at a cement operation. The victim was standing on 2 x 10 x 72 inch planks that were nailed to cross members and placed across a 48-inch diameter hole where a duct was to be installed. Several of the planks dislodged and he fell approximately 75 feet.

- Contractor management policies and procedures were inadequate and failed to ensure that persons could safely work on the deck of the fifth level of the coal mill tower. The wooden platform covering the opening was not substantially constructed and maintained in good condition.
- Contractor management policies and work procedures failed to ensure that fall protection was properly used by persons where there was a danger of falling.
- Contractor management policies and work procedures failed to ensure that persons were aware of safety hazards not immediately obvious. No barricades or warning signs were posted at the approaches to the opening on the deck.

- Ensure that floor openings are protected by railings, barriers, or covers that are properly constructed, installed securely, and maintained to control all hazards.
- Ensure that areas are barricaded or have warning signs posted at all approaches if hazards exist that are not immediately obvious.
- Examine your work places for all possible hazards and correct them before you perform work.
- Remember and use SLAM: Stop, Look, Analyze, and Manage.

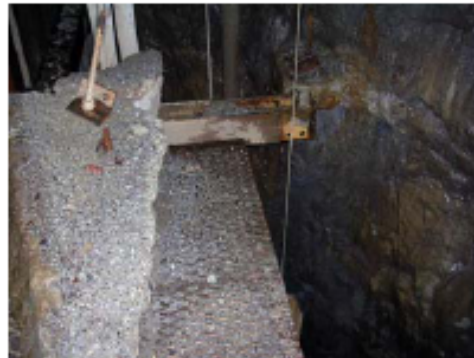
Fatality #19 - July 29, 2007
Fall of Person - Tennessee - Lead/Zinc Ore
East Tennessee Zinc Company, LLC - Immel Mine

METAL/NONMETAL MINE FATALITY - On July 29, 2007, a 29 year-old contractor miner with 3 years experience was fatally injured at an underground zinc mine. The victim and two other contractor miners were working on top of a service hoist located in the main mine service shaft. He was assisting another miner who was using a chipping hammer to remove concrete from around a steel shaft set. The miners had one foot on top of the service hoist and one foot on a cross section H-beam when one side of the beam collapsed. Both miners fell into the shaft. They were both wearing safety harnesses and lanyards but the victim's lanyard was not secured. The other miner was caught by his lanyard but the victim fell 1,000 feet to the shaft bottom.

- Management policies and controls were inadequate and failed to ensure that persons could safely work at elevated positions where there was a danger of falling. Management failed to conduct an assessment of the risk when performing these tasks and had not identified procedures to ensure the work could be completed safely.
- Management policies and work procedures failed to ensure that fall protection was properly used by persons working where there was a danger of falling.

- Ensure workers are trained and understand that safety lanyards are not permitted to be unfastened while working at elevated locations.
- Provide self retracting lanyard mechanisms when workers are required to reposition themselves to perform tasks.
- Ensure safety lanyards are securely fastened at all times when workers are positioned at elevated locations.

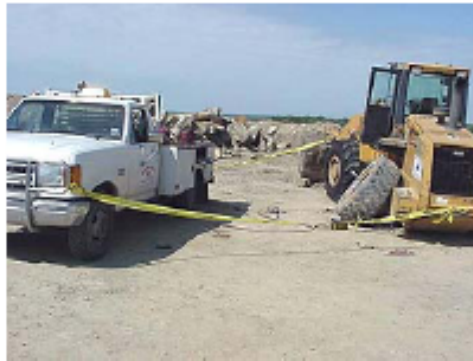
Fatality #7 - April 5, 2007
Falling Material - Texas - Dimension Sandstone
1845 Texas Stone Products, Inc. - Texas Stone Products, Inc.

METAL/NONMETAL MINE FATALITY - On April 5, 2007, a 46 year-old tire contractor, with 8 years experience, was fatally injured at a dimension stone operation. The victim was replacing tires on the front-end loader. He was pinned under the loader when it fell off the supporting jacks.

- Policies and procedures were inadequate. Potential hazards were not addressed before performing the task of changing tires on a wheel loader. Procedures were not established to ensure the wheel loader was blocked against hazardous motion.

- Stop, Look, Analyze, and Manage (SLAM) each task to identify all potential hazards before performing maintenance work. Practice safe work habits during the entire task.
- Train miners and persons hired to perform work on the mine site in safe work procedures before beginning repairs. Monitor work to ensure procedures are followed.
- Securely block equipment against all hazardous motion at all times while performing maintenance work.

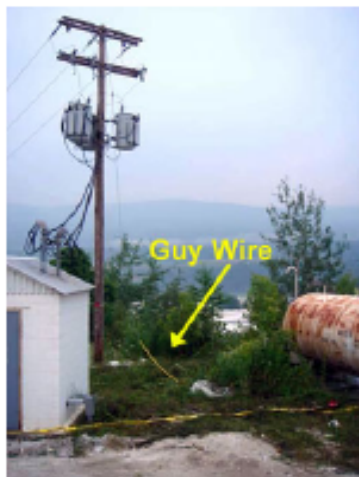
Fatality #18 - July 27, 2006
Determined to be Chargeable 07/31/2006
Electrical - Massachusetts - Limestone (C&B)
Specialty Minerals Inc - Adams Mine

METAL/NONMETAL MINE FATALITY - On July 27, 2006, a 25-year-old contractor laborer, with 2 years experience, was fatally injured at a crushed stone operation. The victim was using a gasoline-powered weed trimmer, equipped with a circular steel blade, to cut weeds and brush near a power pole when he struck the guy wire for the pole. The blade severed the guy wire, causing it to contact the energized supply conductors on the pole mounted transformer and electrocuted him.

- Standards and controls were inadequate. Management failed to inspect and verify that the guy wire was installed properly.
- The provided guy wire on the power pole was not installed in accordance with the National Electrical Safety Code. The guy wire was not provided with two insulators installed to include the exposed section of the guy wire between them. The slackened guy wire contacted the energized transformer supply conductor below the provided insulator, thus energizing the wire.

- Ensure that guy wires from power poles are securely connected to the system ground or are provided with the proper number of insulators installed near the pole end.
- Examine the area for any potential hazards before trimming weeds and brush.

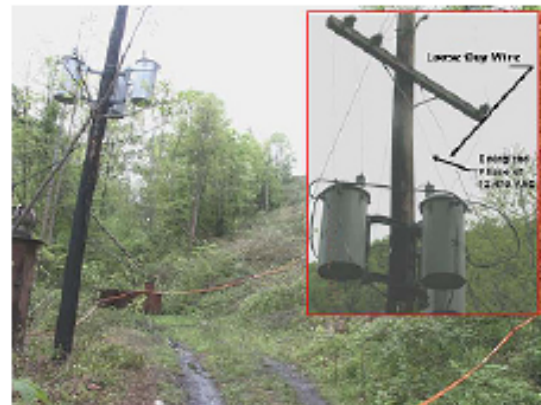
Fatality #38 - May 4, 2006
(Jurisdiction determined 03/05/06)
Electrical - Surface - Virginia
Consolidation Coal Company - Buchanan Mine #1

COAL MINE FATALITY - On Thursday, May 4, 2006, a 40 year old contractor with 2 1/2 years of experience was electrocuted while clearing brush from the right-of-way of a 12,470 VAC transmission line. The miner touched a loose guy wire causing it to contact an energized conductor on the pole. There was no insulator, ground, or proper anchor at ground level preventing the guy wire from becoming energized.

- Connect guy wires securely to the system ground, and/or properly install insulators to protect miners in the event of a breakage.
- Anchor guy wires where they will not be contacted by vehicles and equipment or be disturbed by maintenance personnel.
- Examine areas surrounding electrical installations for potential hazards before beginning any work, including trimming weeds and brush.
- Mark guy wire anchor points for easy identification.

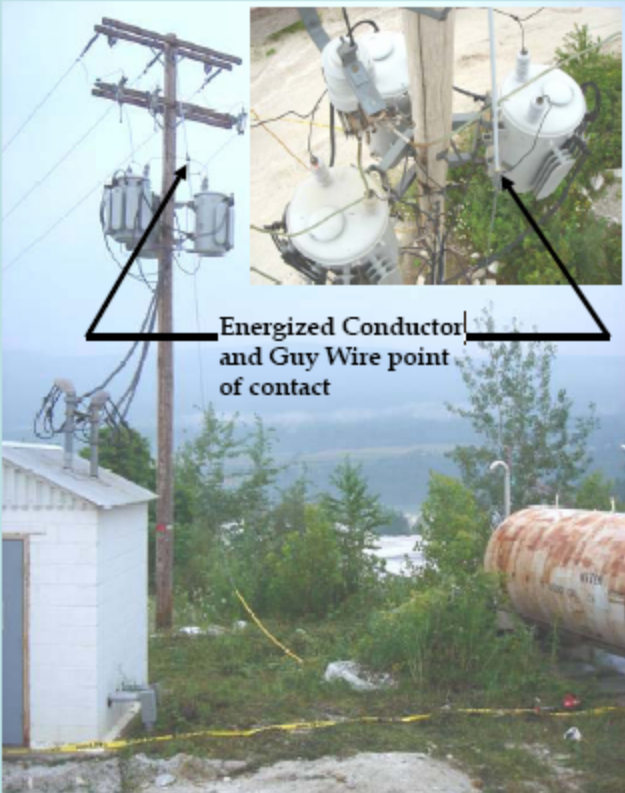
METAL/NONMETAL MINE FATALITY - On July 27, 2006, a miner was fatally injured using a weed trimmer to cut weeds near a power pole when he struck the guy wire for the pole. The blade severed the guy wire, causing it to contact the energized supply conductors on the pole mounted transformer and electrocuted him.

COAL MINE FATALITY - On May 4, 2006, a miner was fatally injured while clearing brush from the right-of-way of a 12,470 VAC transmission line. The miner touched a loose guy wire causing it to contact the energized supply conductors on the pole to which it was attached. There was no insulator, ground, or proper anchor at ground level preventing the guy wire from becoming energized.

- 1) Connect guy wires securely to the system ground, and/or properly install insulators to protect miners in the event of a breakage.
- 2) Adequately anchor guy wires where they will not be contacted by vehicles/equipment or disturbed by maintenance personnel.
- 3) Examine areas surrounding electrical installations for potential hazards before beginning any work, including trimming weeds and brush.
- 4) Mark guy wire anchor points for easy identification.
